## Refurbishment, external refurbishment

▀ Airtight layer as a tanking solution

SA 001

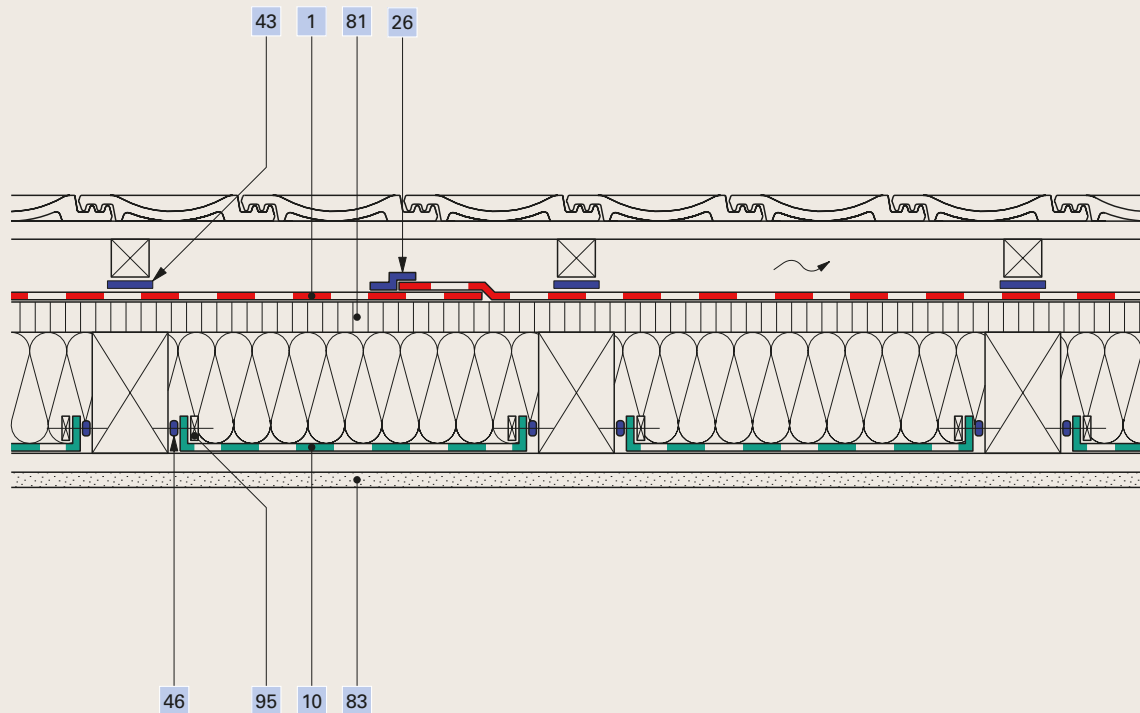
| 1 | Roof membrane <b>Ampatop® Protecta (plus)</b> | 46 | Liquid adhesive <b>Ampacoll® Superfix</b> |
| 10 | Vapour check <b>Ampatex® Variano 3 extra</b> | 81 | Soft wood fibre board |
| 26 | Adhesive tape <b>Ampacoll® Flexx pro</b> , 60 mm | 83 | Inner cladding |
| 43 | Nail sealing tape <b>Ampacoll® ND.Band</b> | 95 | Press-on batten |

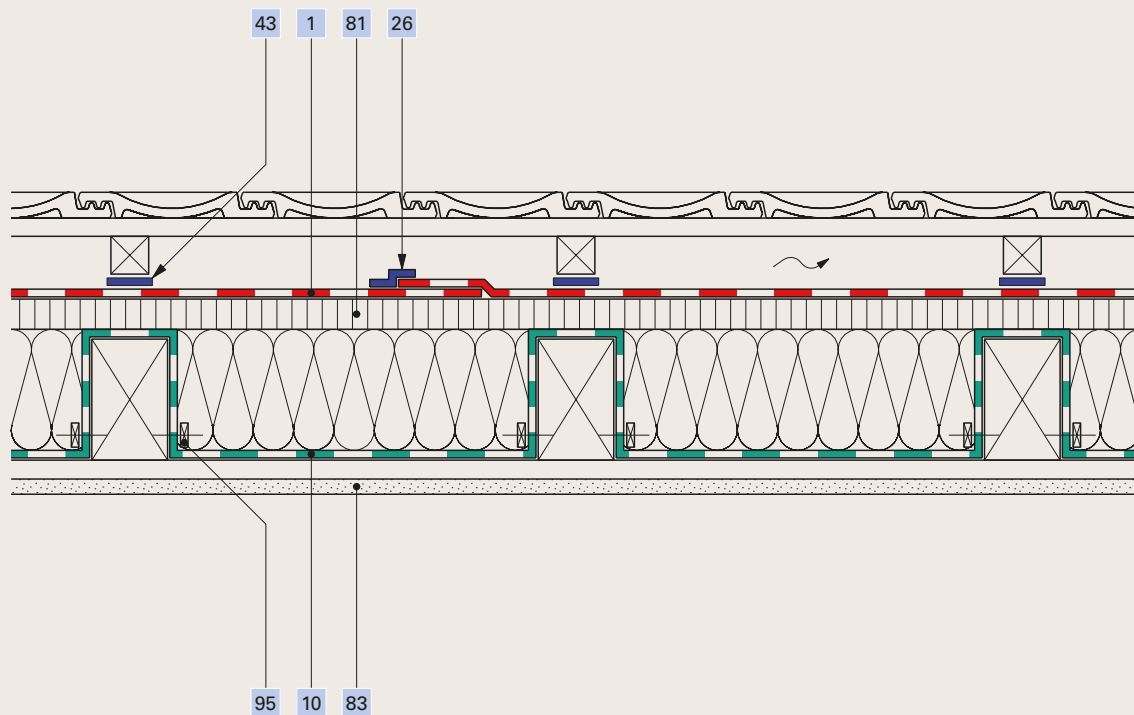
SA 002

▀ Airtight layer positioned around the rafters

| 1 | Roof membrane <b>Ampatop® Protecta (plus)</b> | 81 | Soft wood fibre board |
| 10 | Vapour check <b>Ampatex® Variano 3 extra</b> | 83 | Inner cladding |
| 26 | Adhesive tape <b>Ampacoll® Flexx pro</b> , 60 mm | 95 | Press-on batten |
| 43 | Nail sealing tape <b>Ampacoll® ND.Band</b> | | |

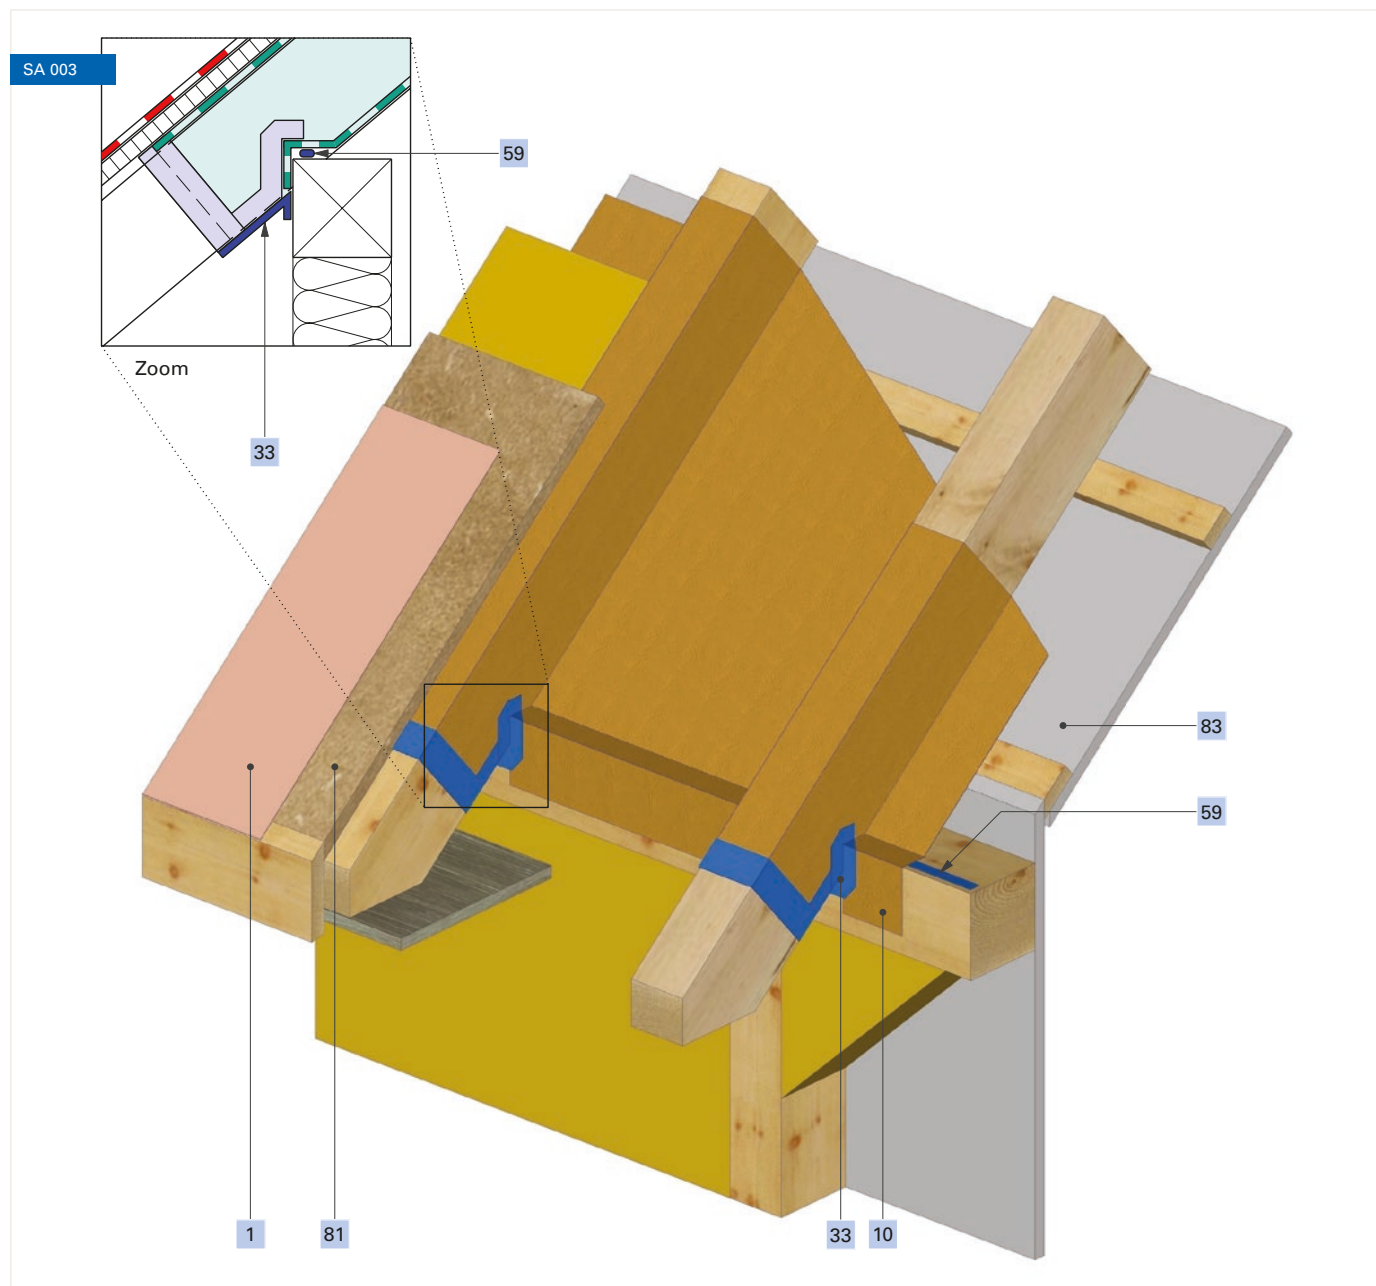
▀ Airtight layer next to the eaves purlins

| 1 | Roof membrane <b>Ampatop® Protecta (plus)</b> | 59 | Liquid adhesive <b>Ampacoll® Profix</b> |
| 10 | Vapour check <b>Ampatex® Variano 3 extra</b> | 81 | Soft wood fibre board |
| 33 | Adhesive tape <b>Ampacoll® BK 535, 50 mm</b> | 83 | Inner cladding |

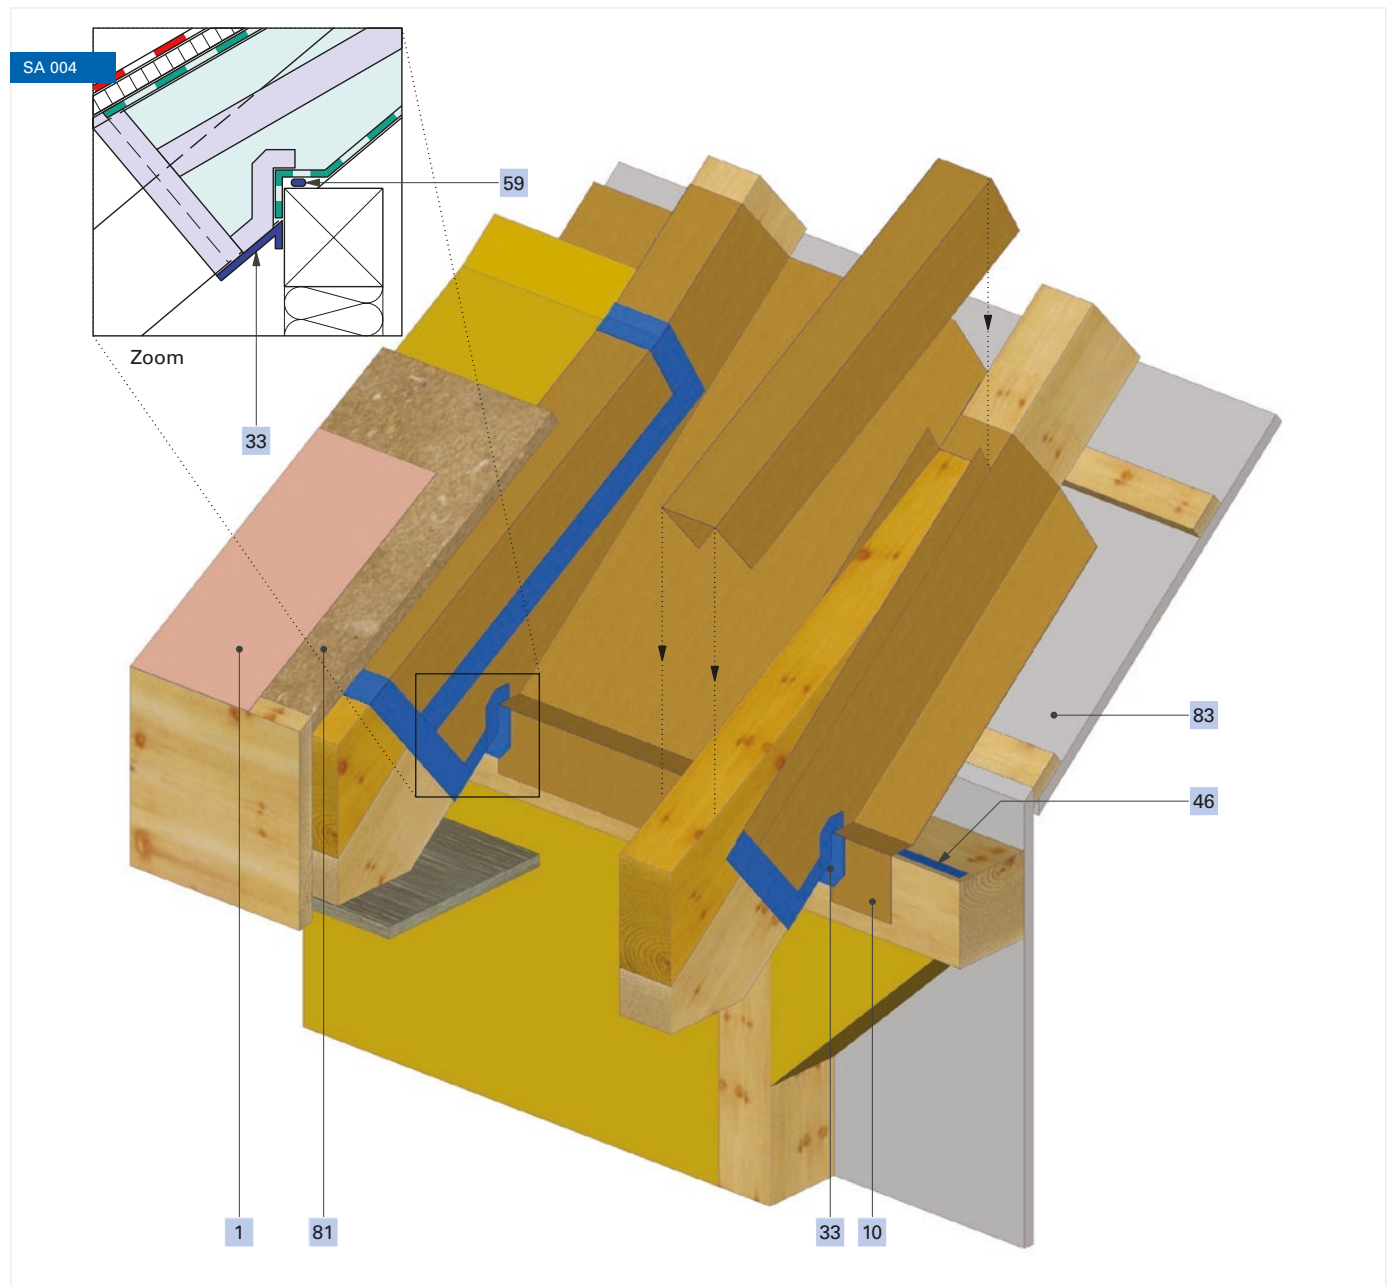
▀ Airtight layer next to the eaves lath

| 1 | Roof membrane <b>Ampatop® Protecta (plus)</b> | 59 | Liquid adhesive <b>Ampacoll® Profix</b> |
| 10 | Vapour check <b>Ampatex® Variano 3 extra</b> | 81 | Soft wood fibre board |
| 33 | Adhesive tape <b>Ampacoll® BK 535, 50 mm</b> | 83 | Inner cladding |

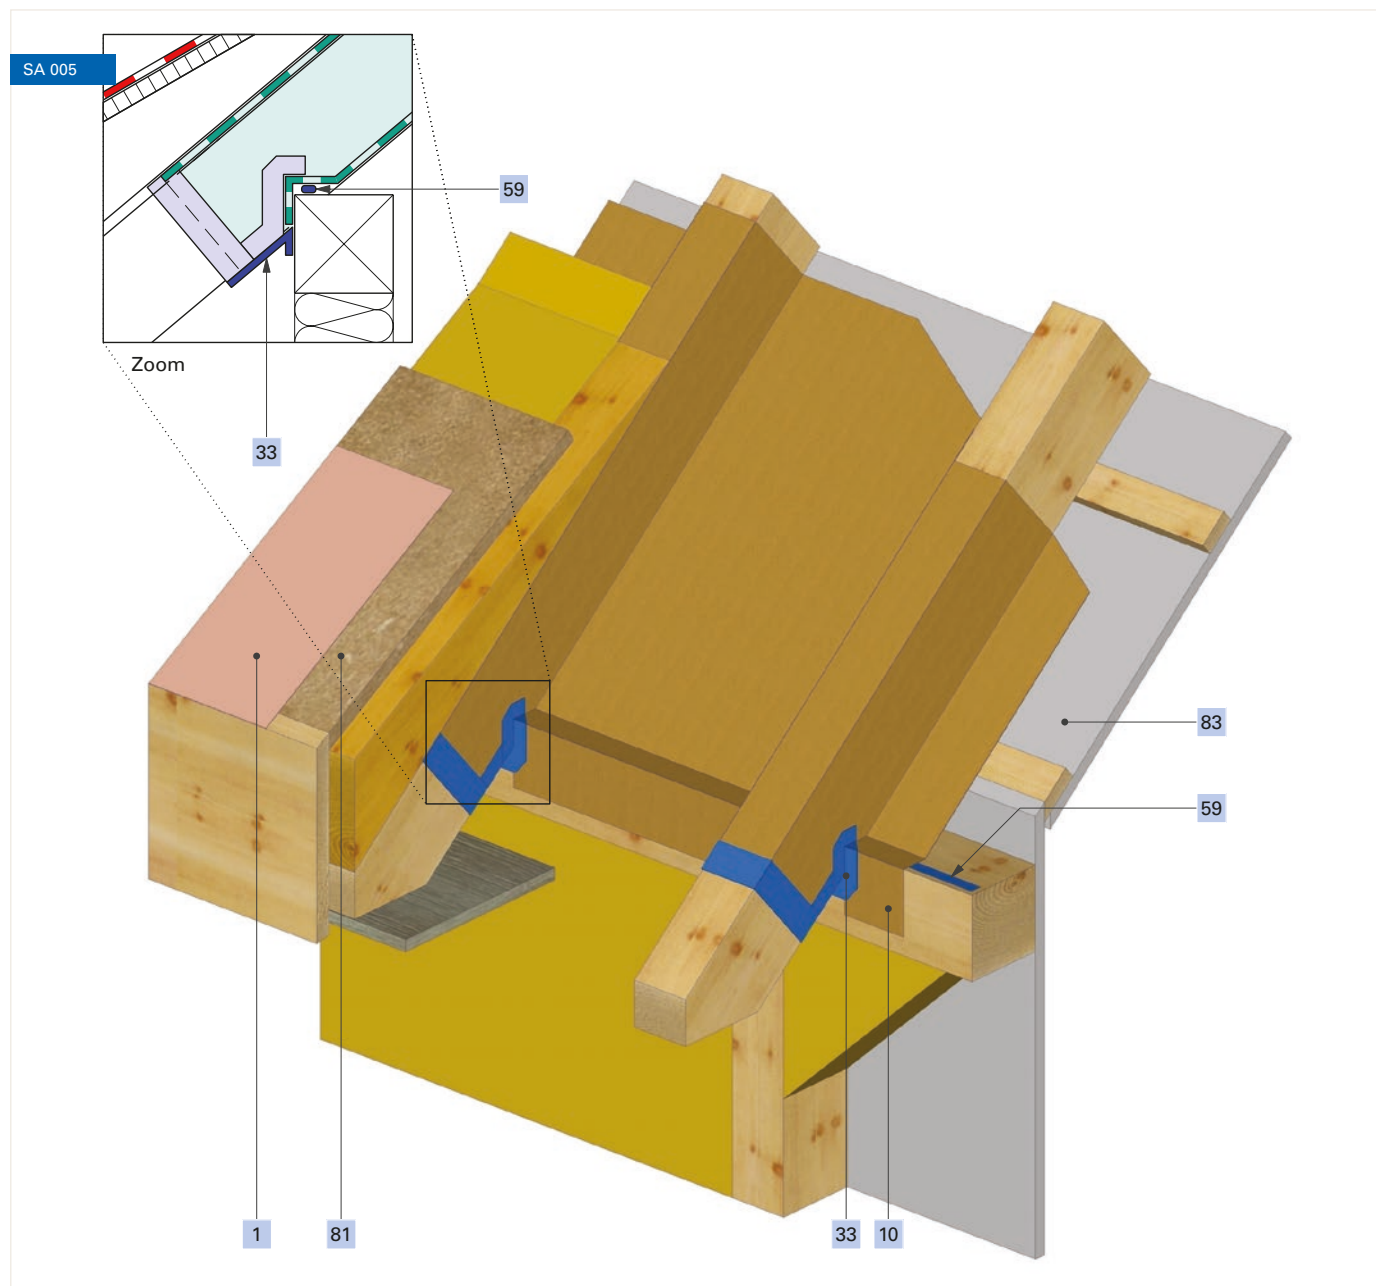
▀ Airtight layer next to the eaves lath

| 1 | Roof membrane <b>Ampatop® Protecta (plus)</b> | 59 | Liquid adhesive <b>Ampacoll®Profix</b> |
| 10 | Vapour check <b>Ampatex® Variano 3 extra</b> | 81 | Soft wood fibre board |
| 33 | Adhesive tape <b>Ampacoll® BK 535, 50 mm</b> | 83 | Inner cladding |

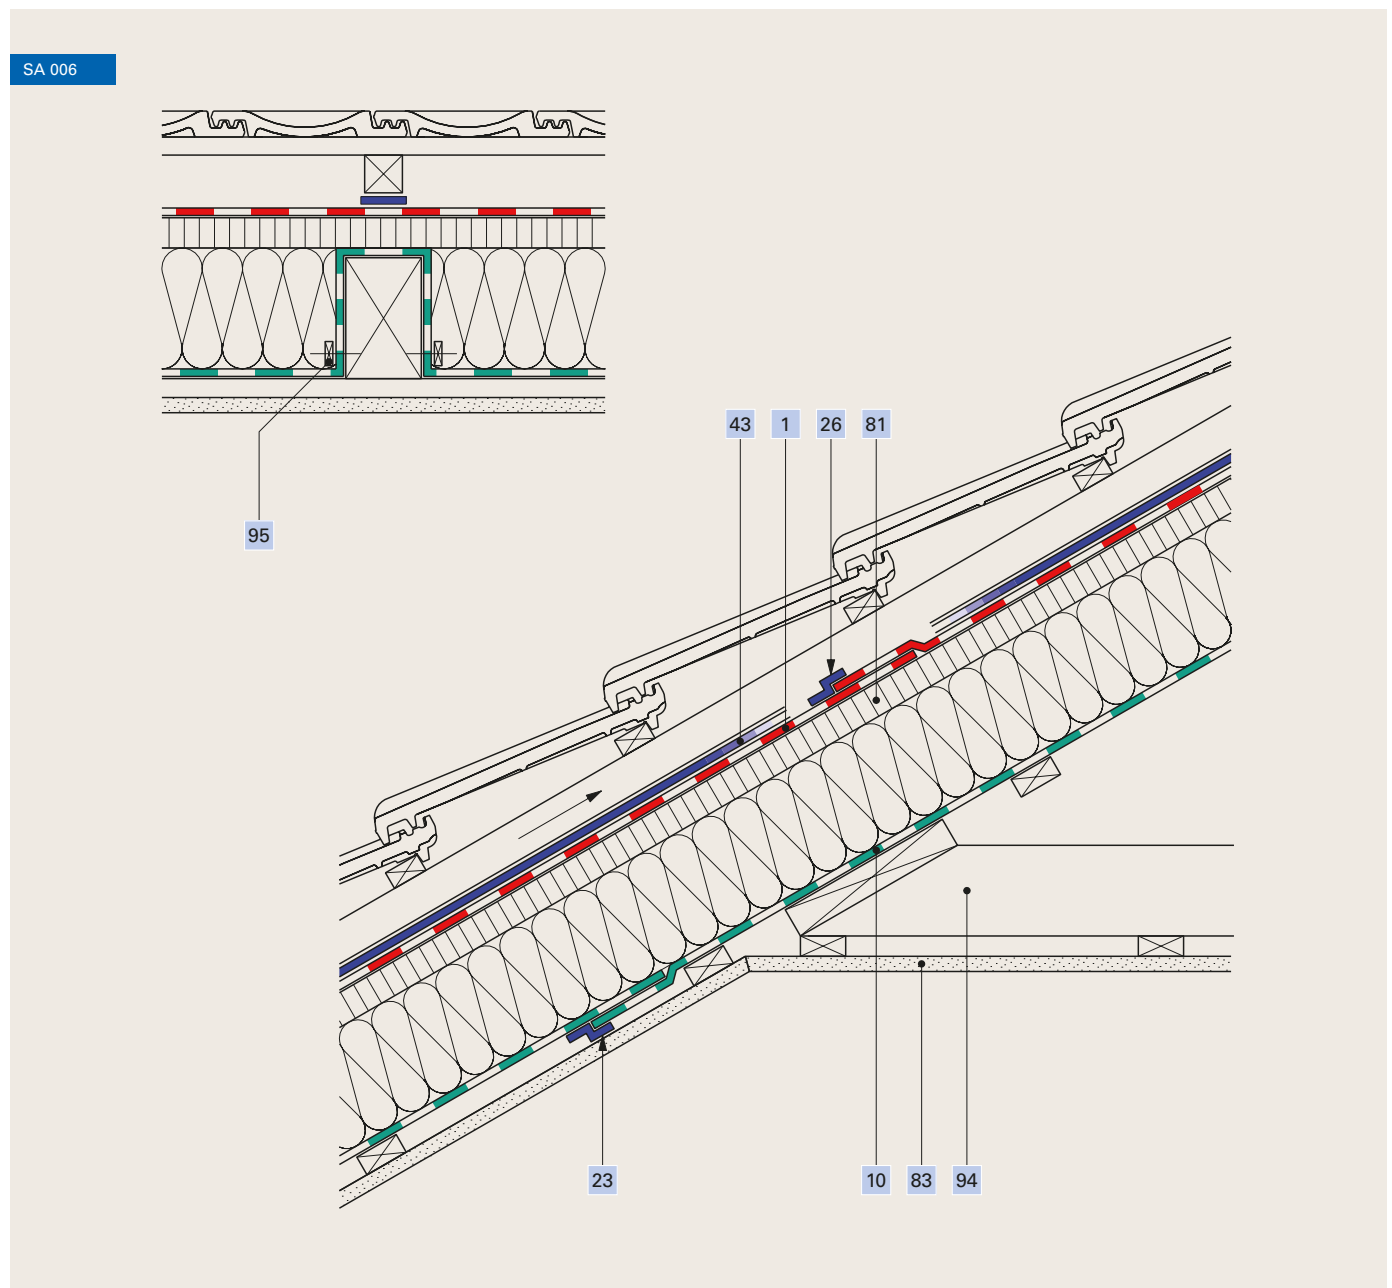
▀ Airtight layer in insulated area under the ridge

| 1 | Roof membrane <b>Ampatop® Protecta (plus)</b> | 81 | Soft wood fibre board |
| 10 | Vapour check <b>Ampatex® Variano 3 extra</b> | 83 | Inner cladding |
| 23 | Adhesive tape <b>Ampacoll® INT</b> , 60 mm | 94 | Plier do not penetrate the air tight layer |
| 26 | Adhesive tape <b>Ampacoll® Flexx pro</b> , 60 mm | 95 | Press-on batten |
| 43 | Nail sealing tape <b>Ampacoll® ND.Band</b> | | |

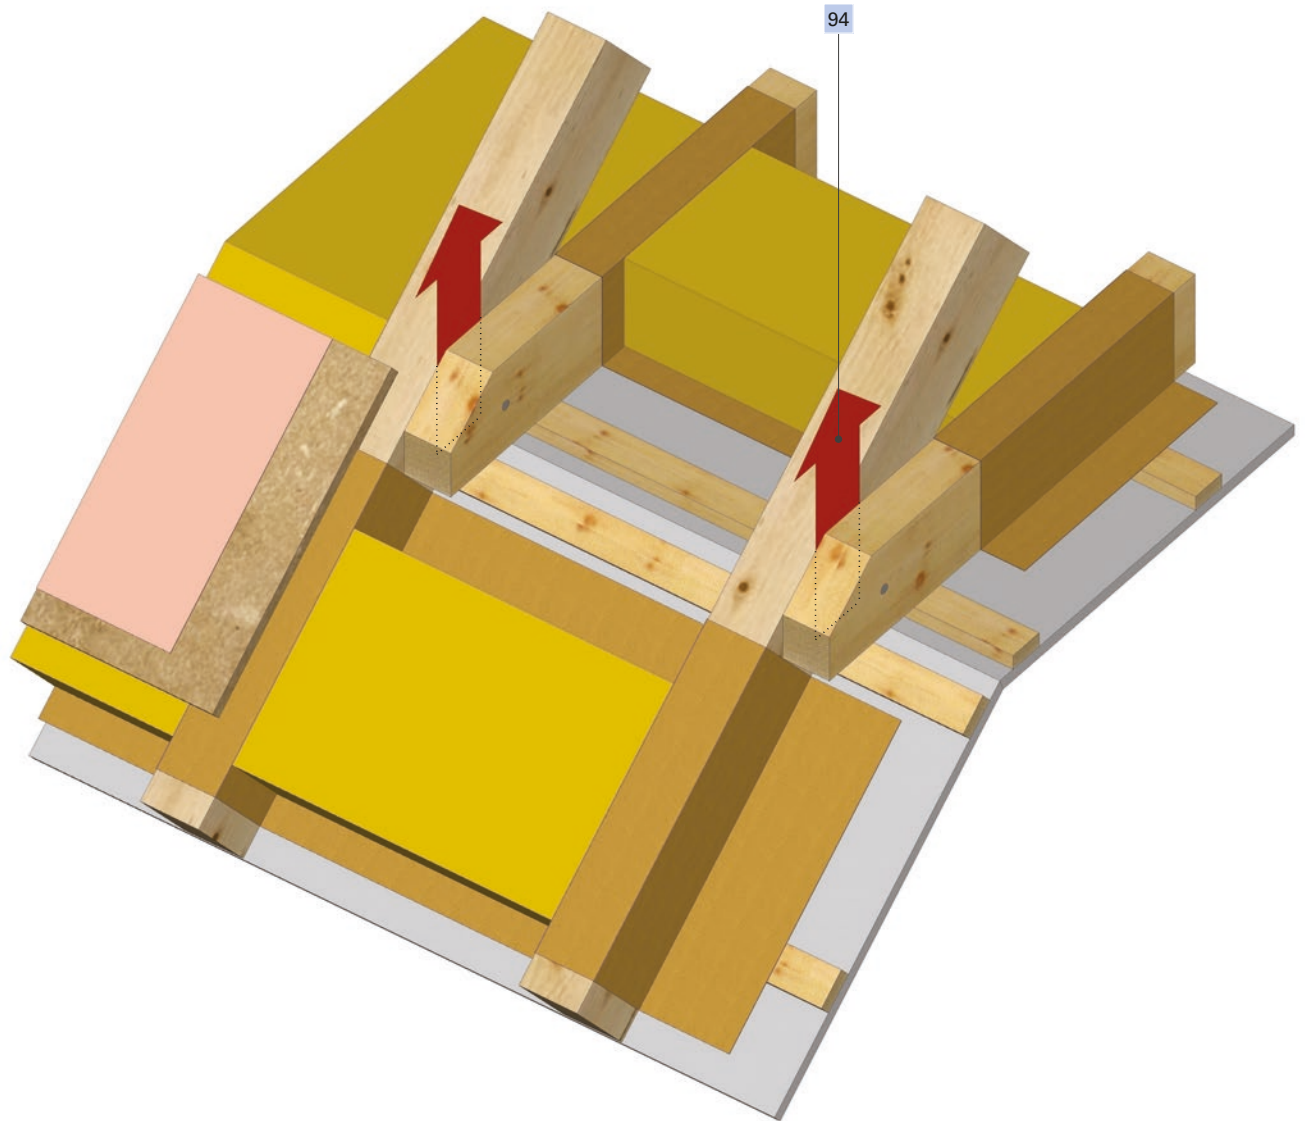
SA 007

▀ Airtight layer and collar beam

94 It is not reasonably possible to seal this joint

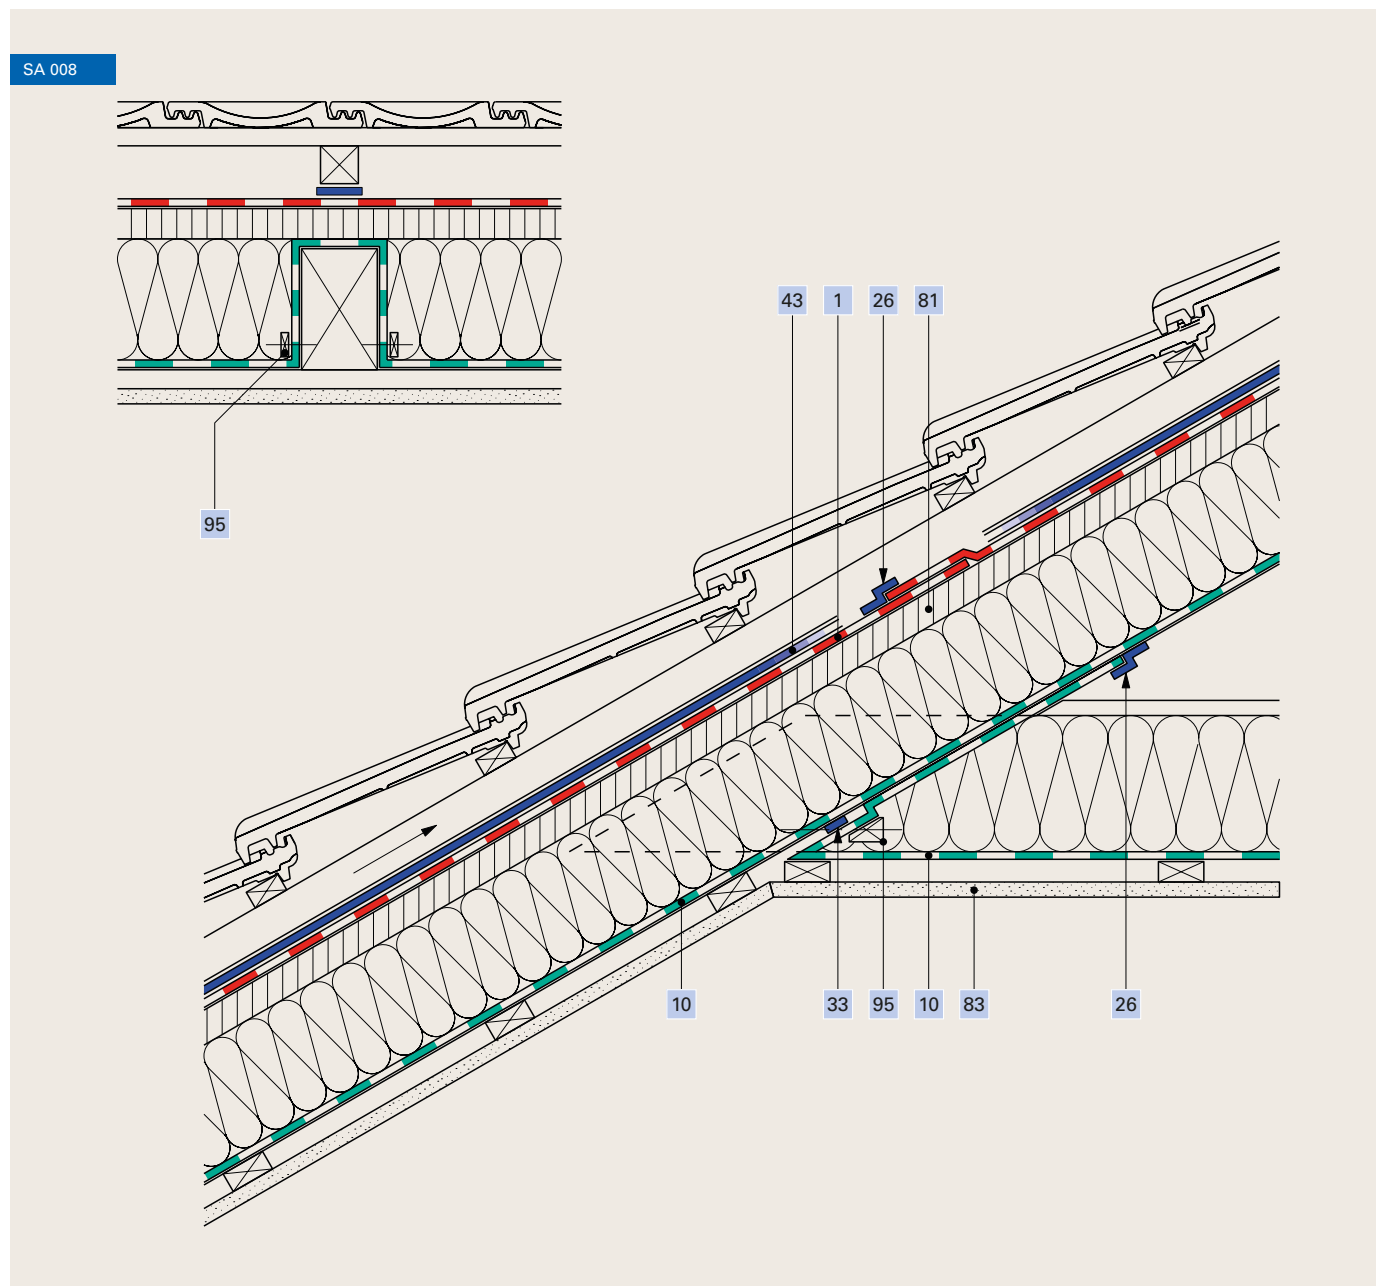
▀ Airtight layer with collar beam insulated from above

| 1 | Roof membrane <b>Ampatop® Protecta (plus)</b> | 43 | Nail sealing tape <b>Ampacoll® ND.Band</b> |
| 10 | Vapour check <b>Ampatex® Variano 3 extra</b> | 81 | Soft wood fibre board |
| 23 | Adhesive tape <b>Ampacoll® Flexx pro</b> , 60 mm | 83 | Inner cladding |
| 33 | Adhesive tape <b>Ampacoll® BK 530</b> , 15 mm | 95 | Press-on batten |

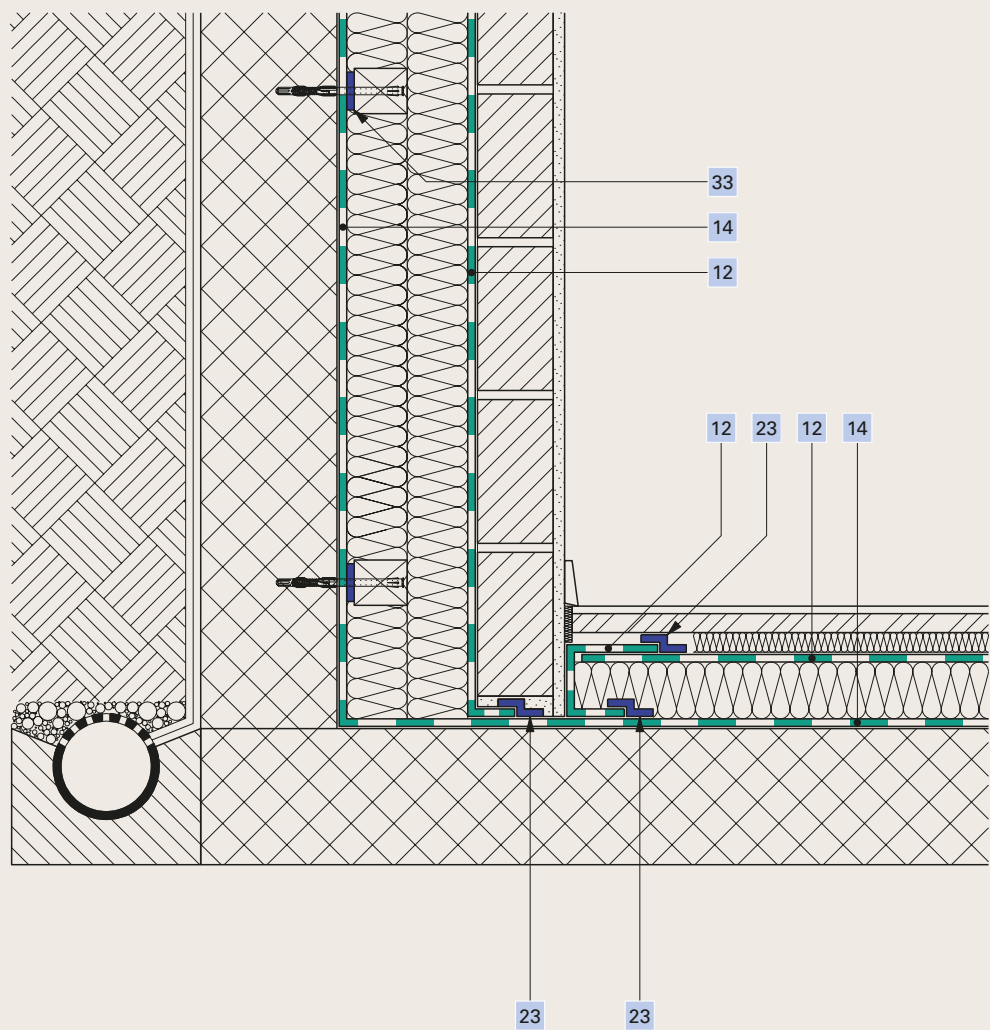
SA 009

Cellar construction with interior insulation and cladding

| 12 | Vapour barrier <b>Sisalex® 514</b> | 23 | Adhesive tape <b>Ampacoll® XT</b> , 60 mm |
| 14 | Vapour barrier <b>Sisalex® 518</b> | 33 | Adhesive tape <b>Ampacoll® BK 535</b> , 50 mm |

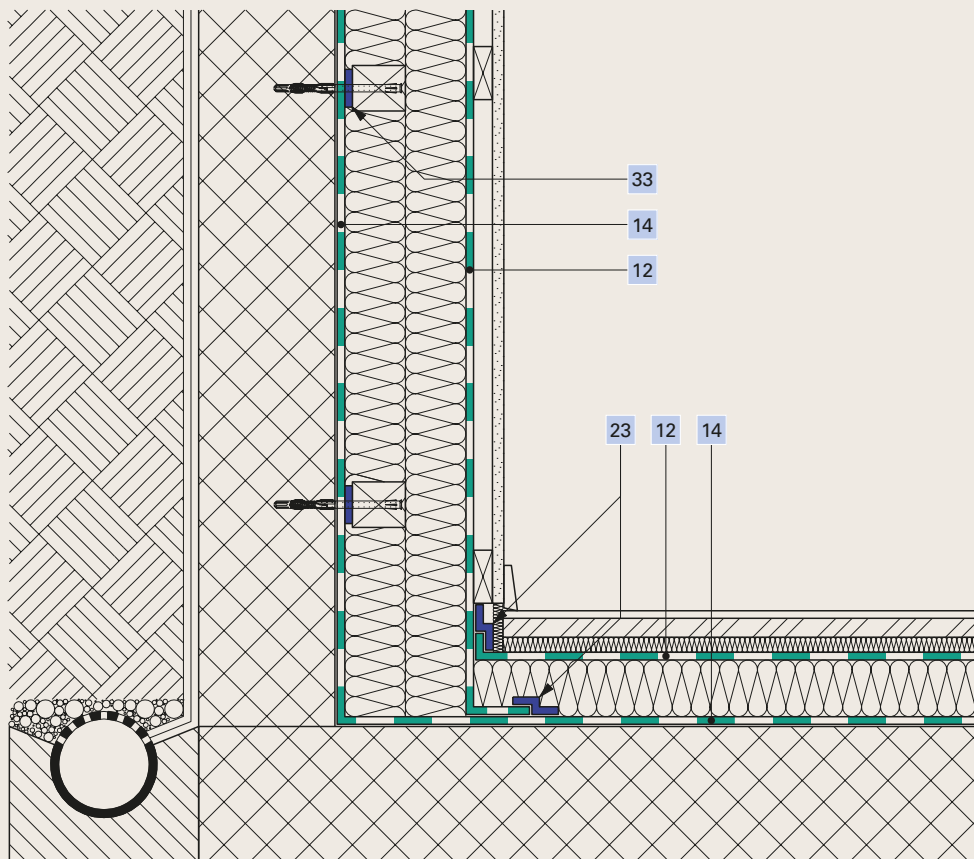
SA 010

Cellar construction with interior insulation and shell

12 Vapour barrier **Sisalex® 514**

14 Vapour barrier **Sisalex® 518**

23 Adhesive tape **Ampacoll® XT**, 60 mm

33 Adhesive tape **Ampacoll® BK 535**, 50 mm

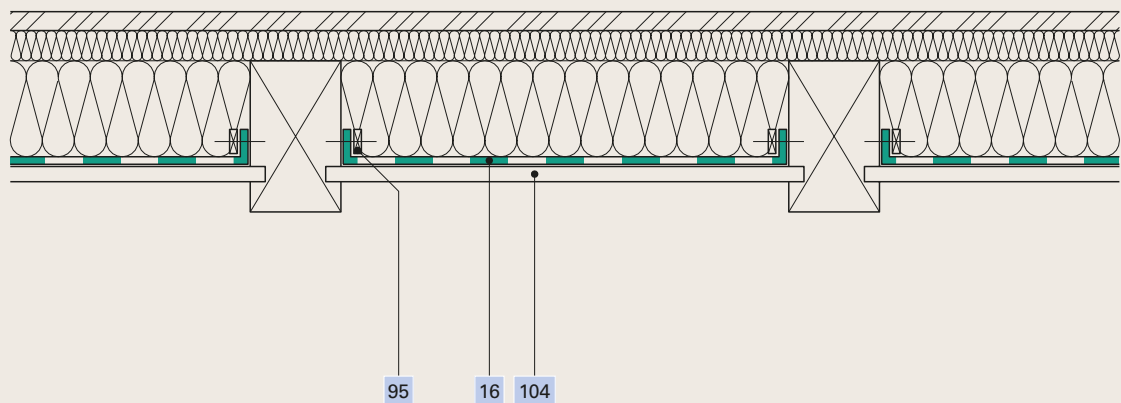
SA 011

## Laying drip protection in ceiling

| 16 | Drip protection <b>Sisalex® 30</b> |
| 95 | Press-on batten |
| 104 | Sliding floor |

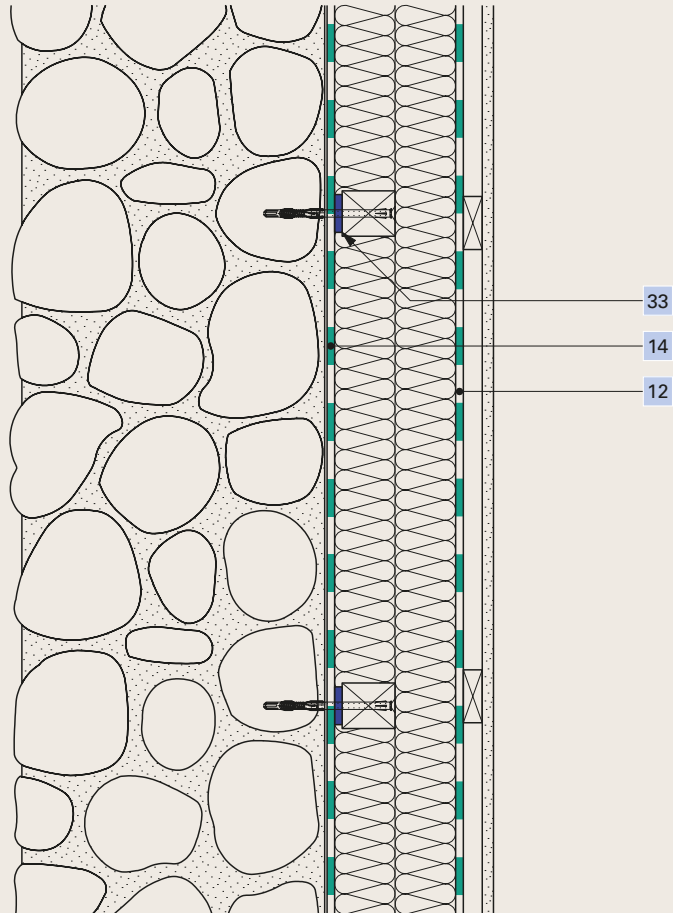
SA 012

## Basement extension with pebble masonry

| 12 | Vapour barrier <b>Sisalex® 514</b> |
| 14 | Vapour barrier <b>Sisalex® 518</b> |
| 33 | Adhesive tape <b>Ampacoll® BK 535</b> , 50 mm |

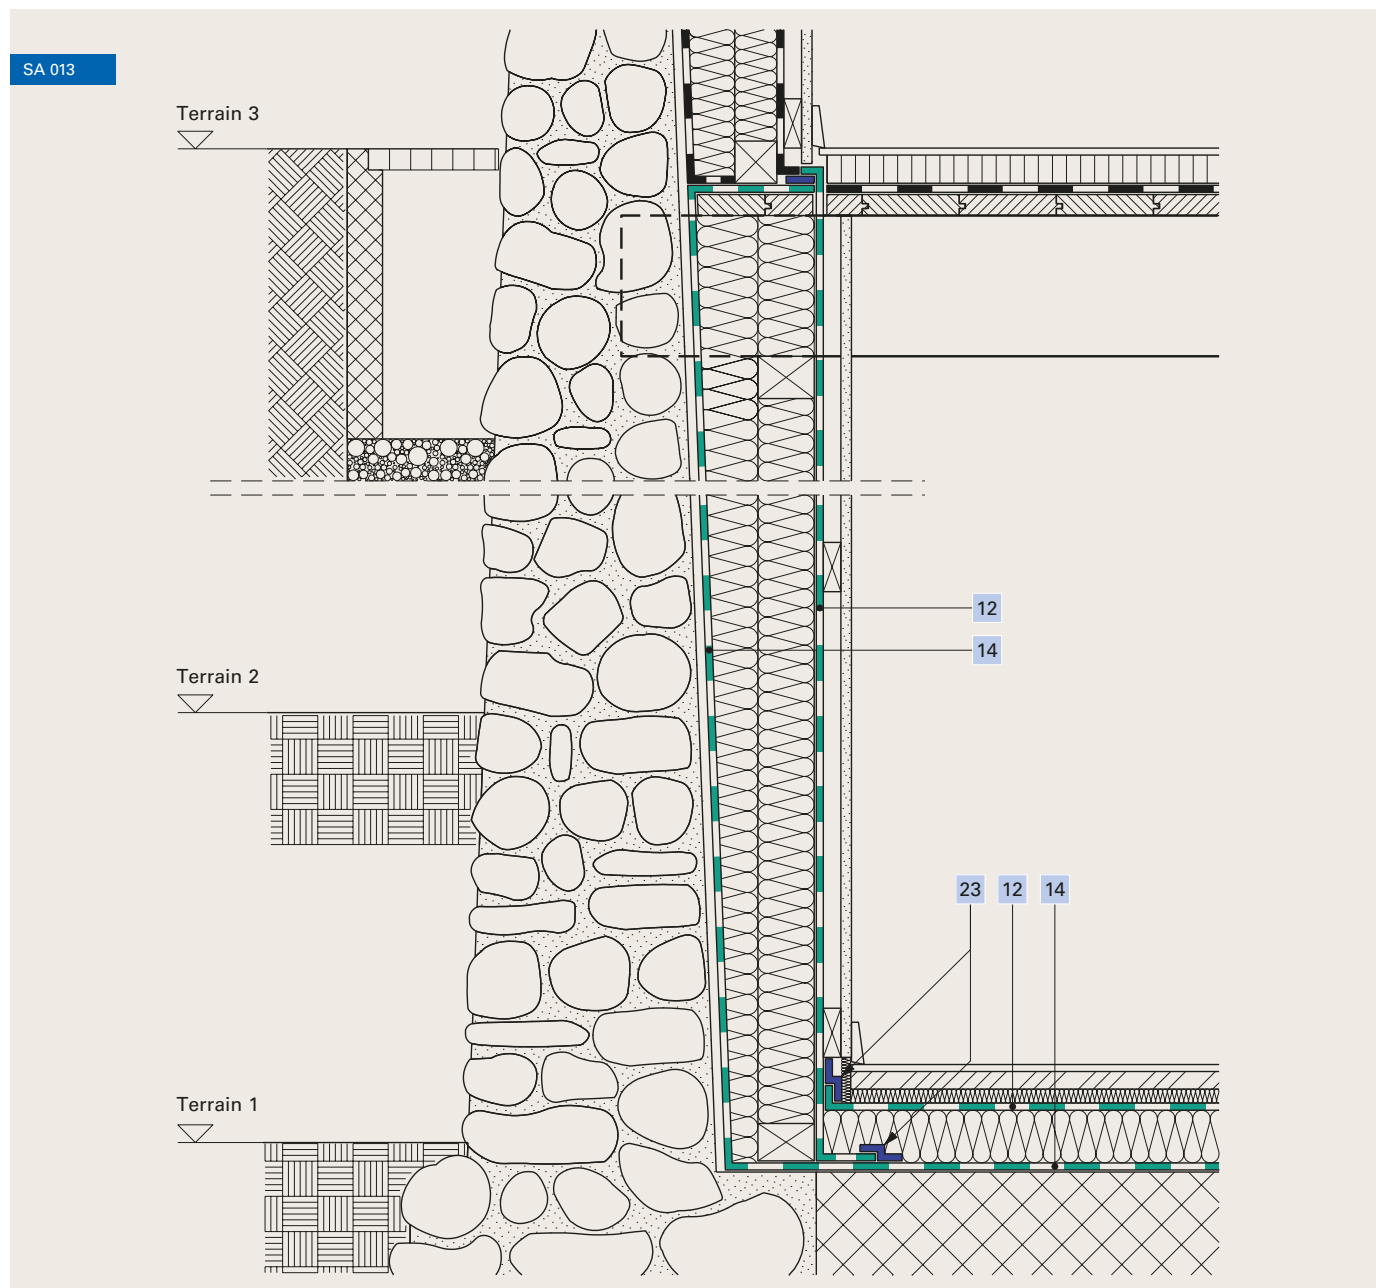
▀ Airtight seal and damp protection in pebble masonry

| 12 | Vapour barrier <b>Sisalex® 514</b> |
| 14 | Vapour barrier <b>Sisalex® 518</b> |
| 23 | Adhesive tape <b>Ampacoll® XT</b> , 60 mm |

Terrain 1+2 No problems

Terrain 3 Caution - damp timber head →  
use mesh to create dehumidifying shaft

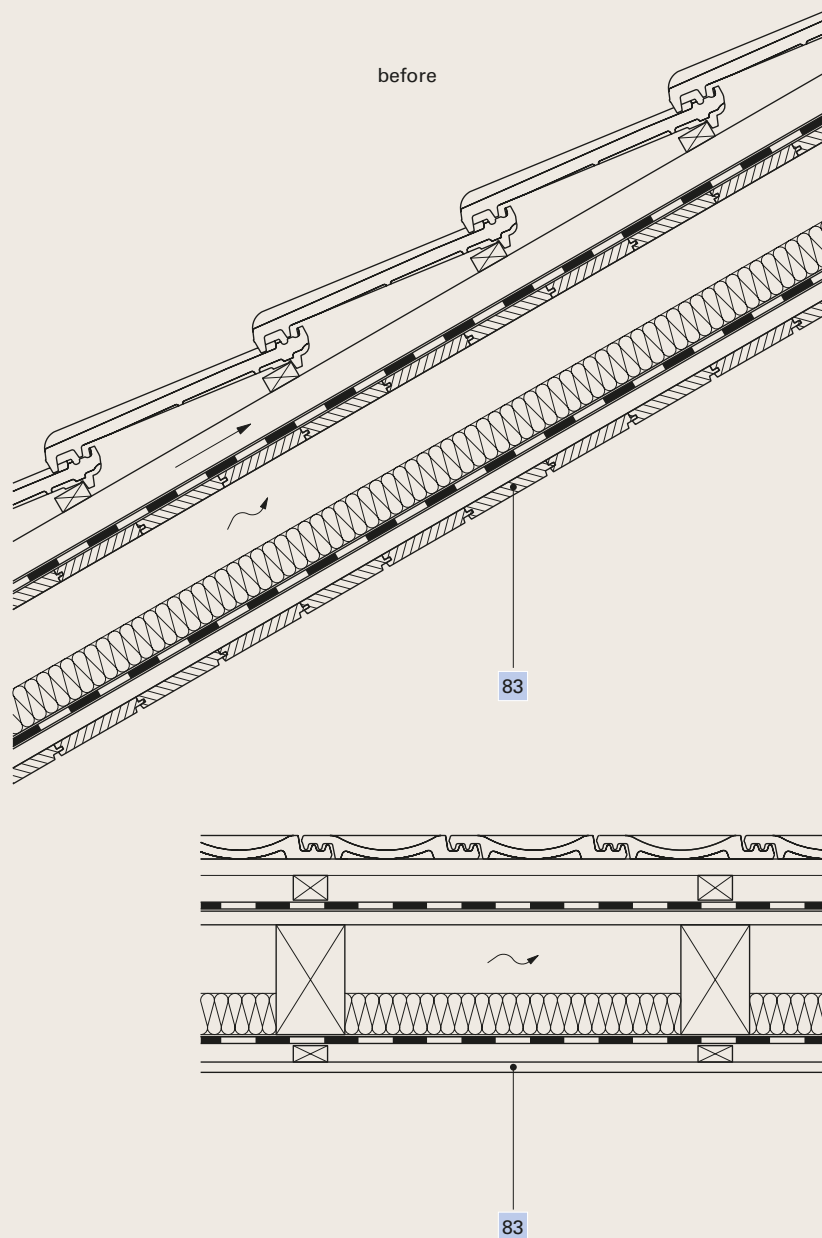
SA 014-1

## Renovation, exterior renovation (before)

- With rafter-mounted insulation
- Air-tight layer above rafters

83 Cladding

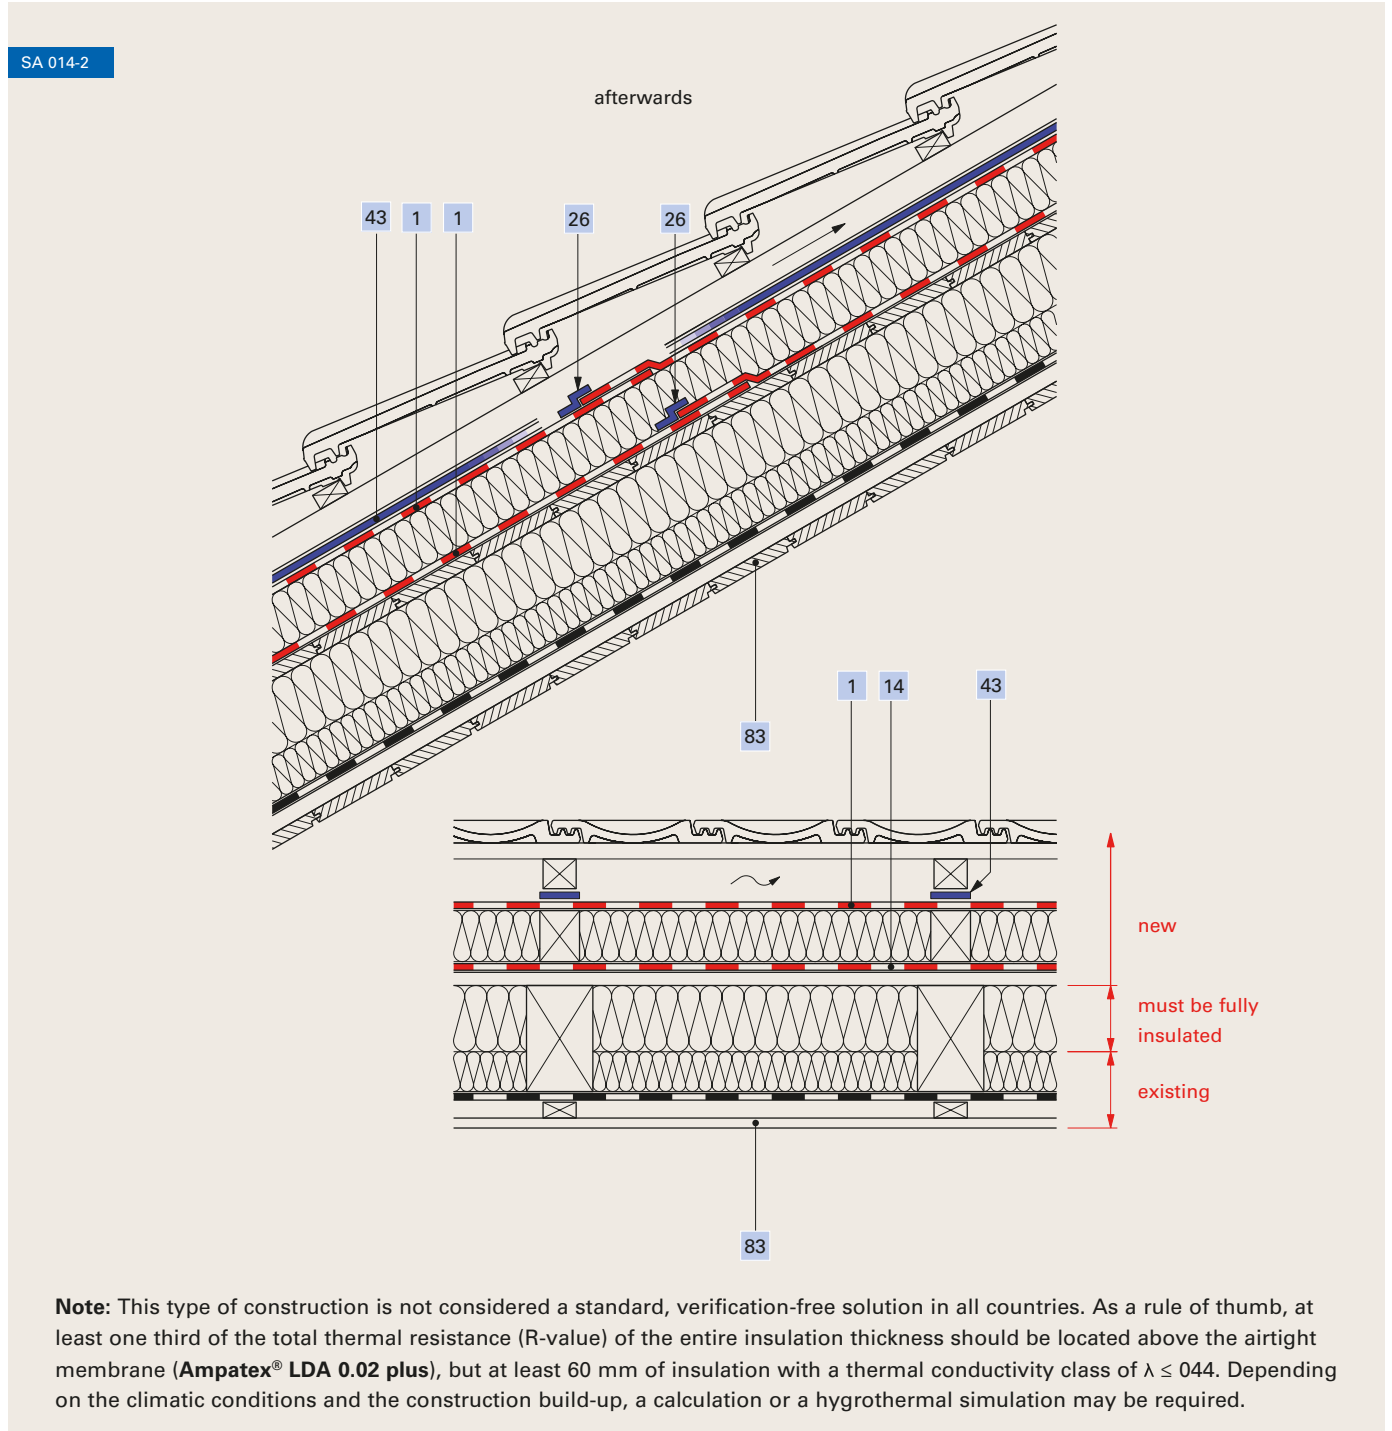
## Renovation, exterior renovation (afterwards)

With rafter-mounted insulation  
Air-tight layer above rafters

| 1 | Roof membrane <b>Ampatop® Protecta (plus)</b> | 43 | Nail sealing tape <b>Ampacoll® ND.Band / Ampacoll ND Duo</b> |
| 14 | Sanierungsdampfbremse <b>Ampatex® LDA 0.02 plus</b> | 83 | Inner cladding |
| 26 | Adhesive tape <b>Ampacoll® Flexx pro</b> , 60 mm | | |
| | Alternative bonding: integrated tapes <b>Ampatop® Protecta plus, Ampatex® LDA 0.02 plus</b> | | |

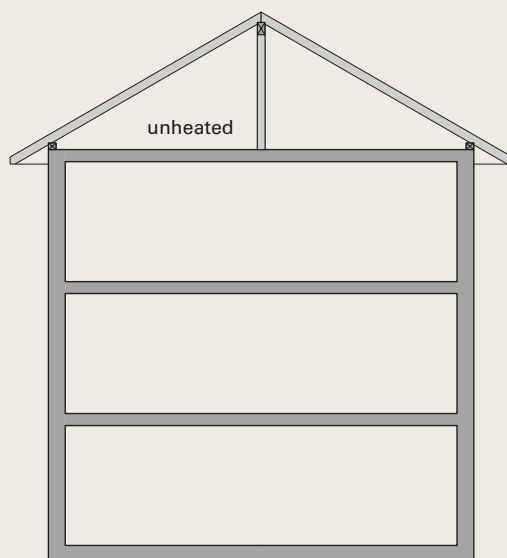
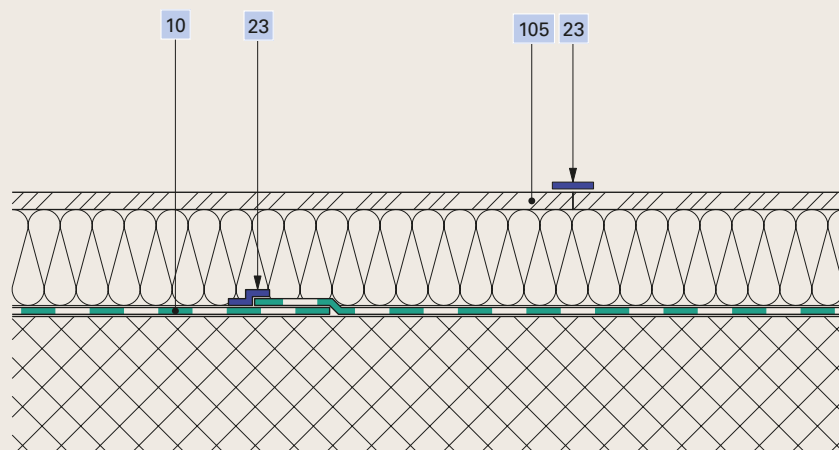
SA 015

## Insulation top floor

Special air-tight layer for penetrations and breakthroughs

| 10 | Formwork membrane <b>Ampatex® Solero</b> ,<br>Vapour check <b>Ampatex® DB 90</b> / <b>Ampatex® Cento</b> |
| 23 | Adhesive tape <b>Ampacoll® XT</b> , 60 mm |

| 105 | Walkable covering, glued, or wall membrane<br><b>Ampatop® Aero (plus)</b> |

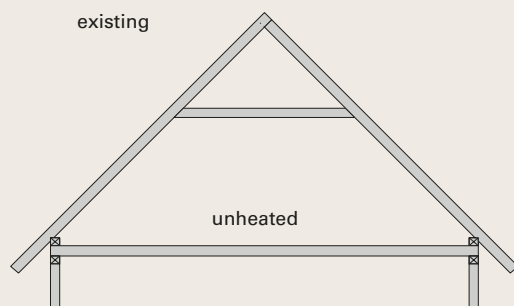
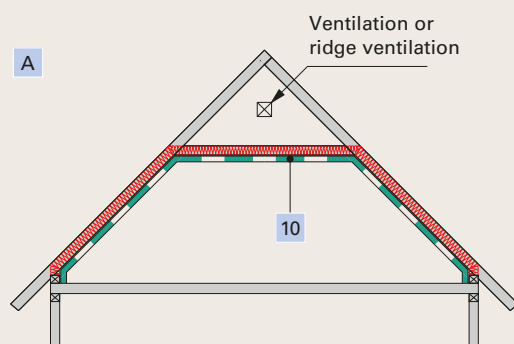
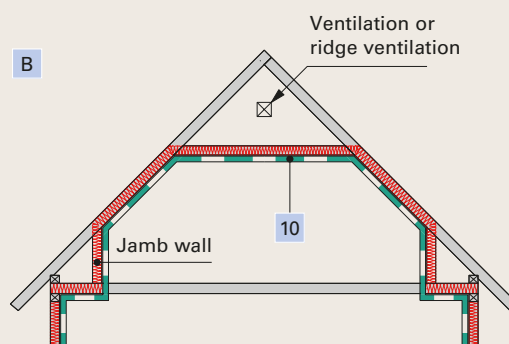
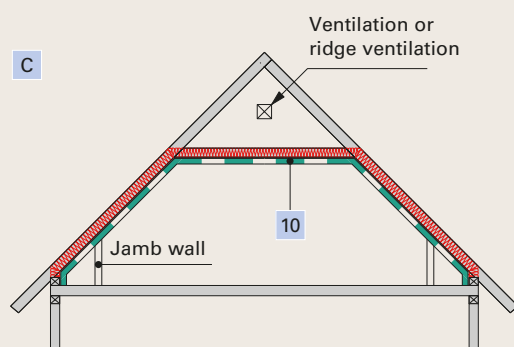
SA 016

## Insulation of old collar beam roof from inside, principles

10 Vapour check **Ampatex® DB 90**

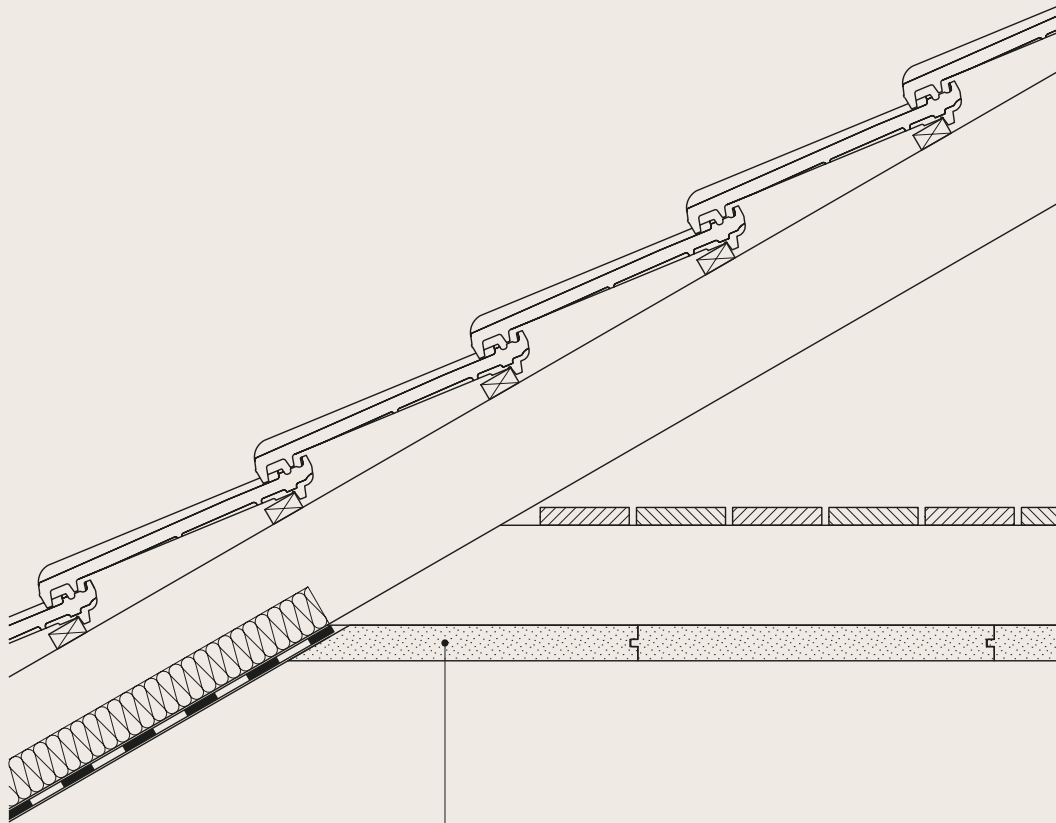
SA 017-1

Exterior insulation of old collar beam roofs (before)

83 Cladding
