## Refurbishment, external refurbishment

▀ Airtight layer as a tanking solution

SA 001

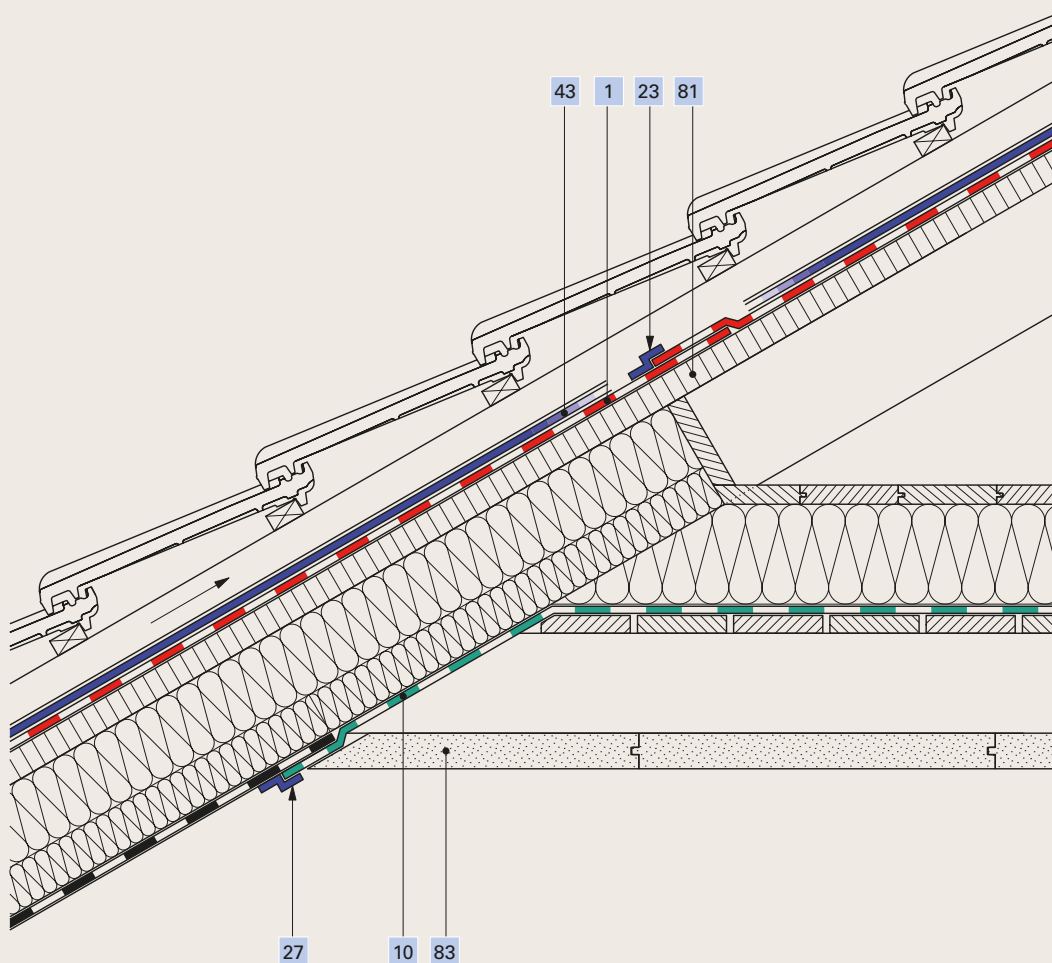
SA 017-2

## Exterior insulation of old collar beam roofs (afterwards)

| 1 | Roof membrane <b>Ampatop® Protecta (plus)</b> | 43 | Nail sealing tape <b>Ampacoll® ND.Band</b> |
| 10 | Vapour check <b>Ampatex® DB 90</b> | 81 | Soft wood fibre board |
| 23 | Adhesive tape <b>Ampacoll® XT, 60 mm</b> | 83 | Cladding |
| 27 | Adhesive tape <b>Ampacoll® INT</b> | | |
